INSTALLATION RESTORATION PROGRAM

PRELIMINARY ASSESSMENT

Alabama Army National Guard

Dannelly Field Municipal Airport
Montgomery, Alabama

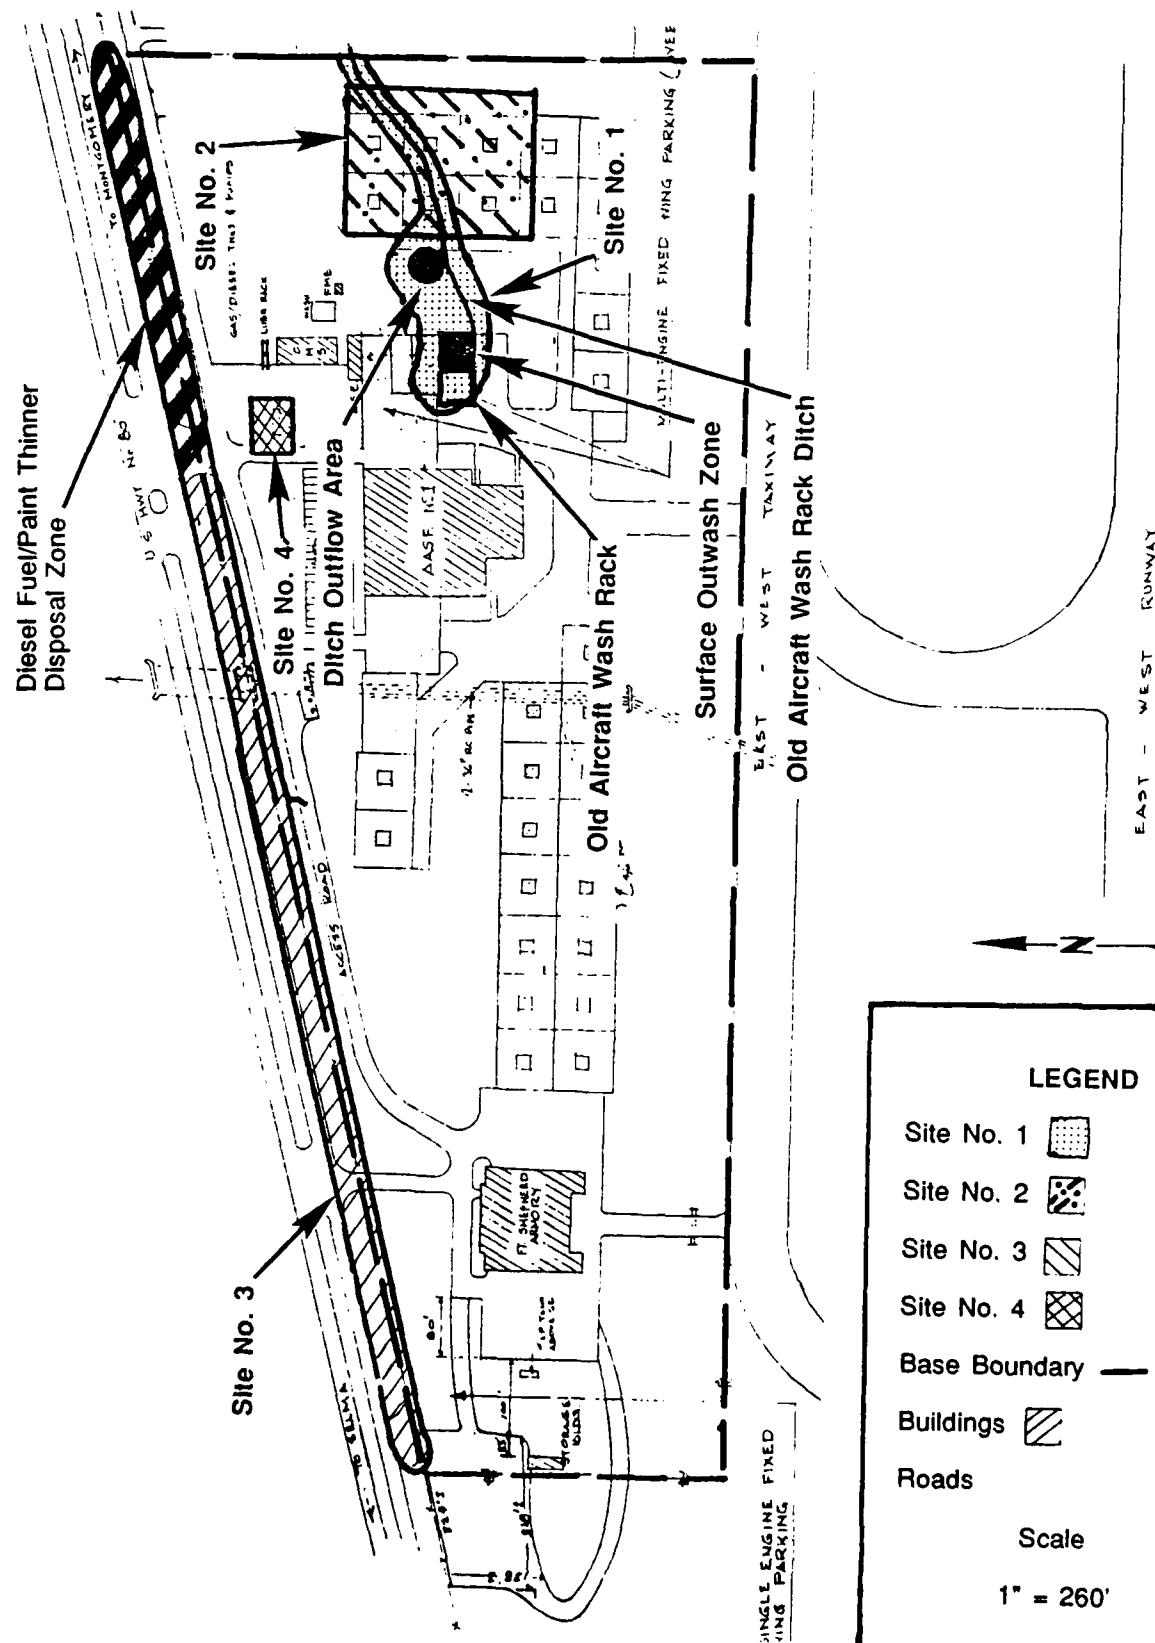
Figure IV.1
Potential Sites
at the Base

From 1960 to 1973, the Old Aircraft Wash Rack was in operation at the northeast corner of the pavement adjacent to the east side of old AASF No. 1. Site No. 1 is a surface drainage area once associated with activities at this wash rack.

The Surface Outwash Zone is a large area of soil adjacent to the east side of the Old Aircraft Wash Rack. This area is indicated by a large, dark, irregular stain on a 1972 aerial photograph. This stain may reflect surface movement of water and contaminants from the rack into the adjacent soil.

No. 1, the portion of Site No. 1 on the Base was disturbed. This is evident from aerial photographs taken during the three year construction period. Thus, if contaminated soil was present at Site No. 1, a portion of it was probably redistributed on-site by heavy equipment. With possible soil contamination at Site No. 1, there is also a potential for groundwater contamination. Consequently, a Hazard Assessment Score (HAS) was calculated for this potential site.

The PA identified four potentially contaminated sites. As a result, additional work under the IRP is recommended for these sites to confirm the presence or absence of contamination.
